THERAC-25

THE INVESTIGATION OF THE THERAC-25 ACCIDENTS.

Vassili Zdanov

Tallinna Tehnikaülikool

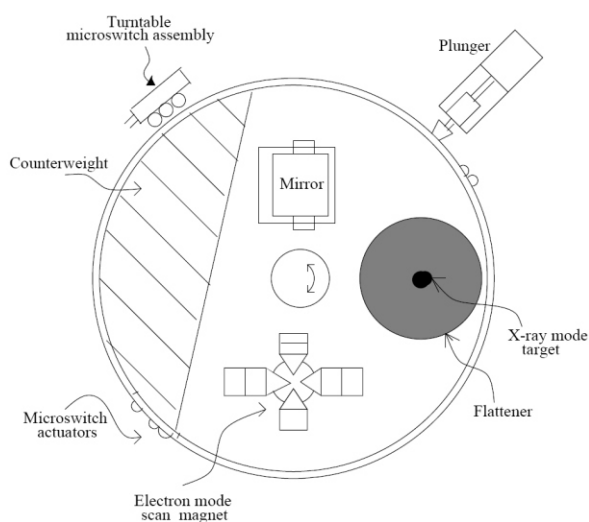
Figure 1. Upper turntable assembly

If the flattener is not on the appropriate position, an overdose occurs. This is the basic hazard of the dual-mode machines. The computer is responsible for the turntable position so that a target, flattening filter and X-ray ion chamber are on the beam path.

In Therac-25 software checks were substituted for traditional hardware interlocks.

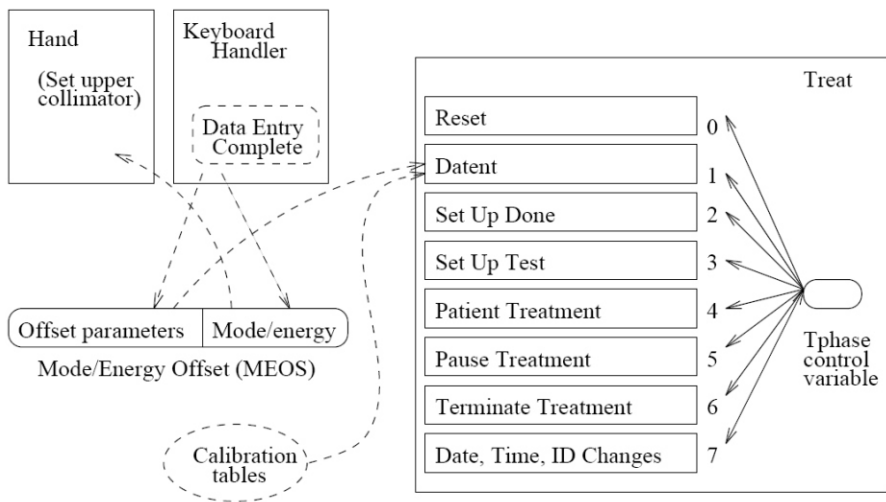
Figure 3. Tasks and subroutines that caused the accident [1]

Treatment Monitor Task (Treat) has 8 main subroutines that control the phase of the treatment. The *Tphase* control variable stores the information to determine which subroutine should be executed. After the execution Treat reschedules itself.

The second subroutine called *Datent* (Data entry) determines if the prescription data is entered. It examines the Data Entry Complete flag. After the variable is set, the *Datent* changes the value in *Tphase* from 1 to 3 (*Set Up Test*). If the variable is not set, then the *Datent* reschedules itself and does not change the value in *Tphase* and exits back to Treat's mainline.

When operator completes all the necessary steps to the prescription then the cursor is moved to the "Command" line as the normal position (See fig. 2). The *Data Entry Complete* variable does not check that the cursor is located on the "Command" line therefore causing a potential error. In some cases, the data entry phase can exit before all changes are made on the screen. Mode and energy is set through one byte of the *MEOS* variable, which is used to set the proper collimator position for the treatment. If this byte is wrong, then the collimator sets the wrong position.

If the keyboard handler sets the *Data Entry Complete* flag before the operator changes the data in *MEOS* entry, then changes will not affect the *Datent* because it has already exited and will not be reentered. When the parameters are set, the *Datent* calls the subroutine *Magnet* that bends and sets the magnets for their appropriate position. Setting these magnets takes about 8 seconds. The first thing that *Magnet* does is to call a subroutine *Ptime* to make a time delay. Because there are many magnets to be set, the *Ptime* subroutine is entered several times and reschedules itself. When the bending magnets are set *Ptime* is cleared. *Ptime* then checks a shared variable that indicates if any changes have been made. If the variable is set, then edits were made and *Ptime* variable clears the values if the bend magnets and exits to *Magnet* which exits back to *Datent*. But this shared variable is checked only when the bending magnets flag is set. *Ptime* clears the flag during the first execution therefore any changes made during each succeeding pass through *Ptime* will not be detected.

The accident happened in April 1985 when the operator made the entry of energy and mode, moved to the command line then moved the cursor to change the mode and moved back to the command line all in less than 8 seconds that takes the magnets to be set. The editing of the mode has never been detected because *Magnet* does not recognize the edits after the first execution of *Ptime*.

But that is not all. After exiting the *Magnet* subroutine, the *Datent* checks the *Data Entry Complete* flag. If it is set, then *Datent* moves to the next phase *Set Up Test*. If not, *Datent* leaves the *Tphase* without any changes. *Data Entry Complete* flag only checks that the cursor is on the command line, not that it is still there.

AECL fixed those problems. The bending magnets variable is cleared at the end of the *Magnet* subroutine, not *Ptime* subroutine. A new variable was introduced in order to check if the cursor is not positioned on the command line.

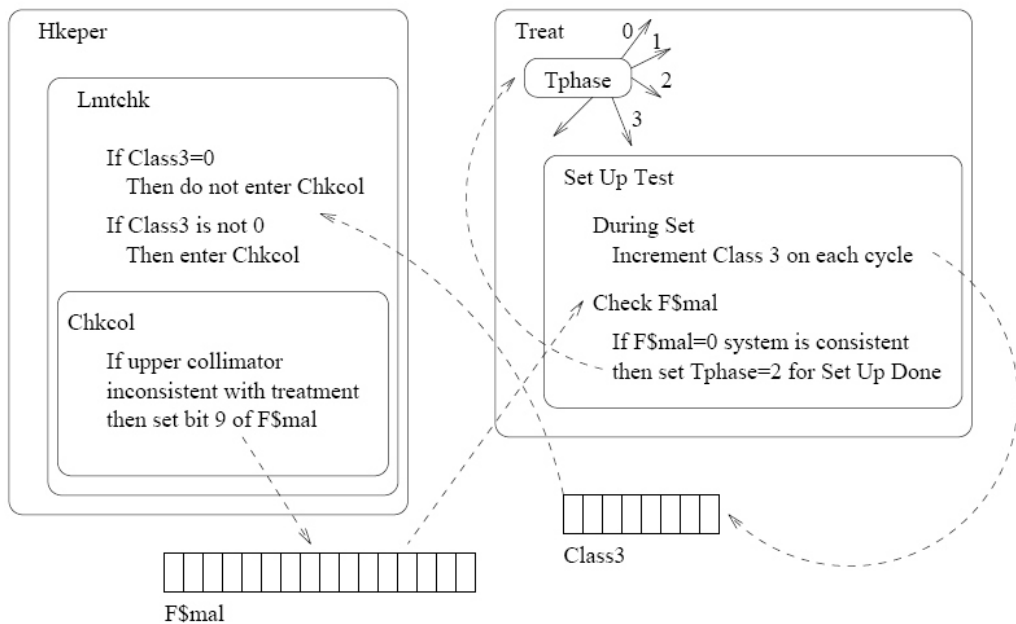
Figure 5. Tasks and subroutines that caused the sixth accident [1]

The prescription is entered at the console after patient has been placed and unverified parameters entered. The same *Datent* routine verifies the data. The next subroutine *Set Up Test* is executed. To check the collimator position, a shared variable *Class3* is set and increments every pass through *Set Up Test* subroutine. *Class3* value should be equal to zero for the treatment to proceed, if not the treatment is not proceeded. If *Class3* variable equals to zero, then *Set Up Test* subroutine calls another shared variable to check if any malfunctions present. The variable is called *F\$mal*. In order for the treatment to continue both *Class3* and *F\$mal* should be equal to zero. In this case *Tphase* variable is set to 2 and next *Set Up Done* subroutine is executed. If not, *Set Up Test* subroutine is rescheduled.

There are no hardware interlocks in Therac-25. The only software interlock that checks the collimator position is performed by *Lmtchk* subroutine. *Lmtchk* controls both *Class3* and *F\$mal* for their value to be equal to zero.

Obviously, *Set Up Test* will be executed many times during the setup because it reschedules itself every time an event occurs. As it was said earlier, the value in *Class3* is incremented every time it passes through *Set Up Test*. This value is 1 byte long which equals to 8 bits and maximum decimal value of 255 (from 0 to 255). That means, that every pass through the value 256 the actual value is set to 0 and that means that at this time the collimator position will not be checked. Since *Set Up Test* is executed hundreds of times during the setup, a couple of checks will not be performed.

The accident happened at the exact moment when the operator pressed “set” command on the 256th check. Consequently, *F\$mal* was not set and software turned the X-Ray beam with full energy of 25MeV delivering a massive overexposure to patient.

AECL fixed the error by changing the *Class3* value to nonzero value. The solution was quite simple to implement.

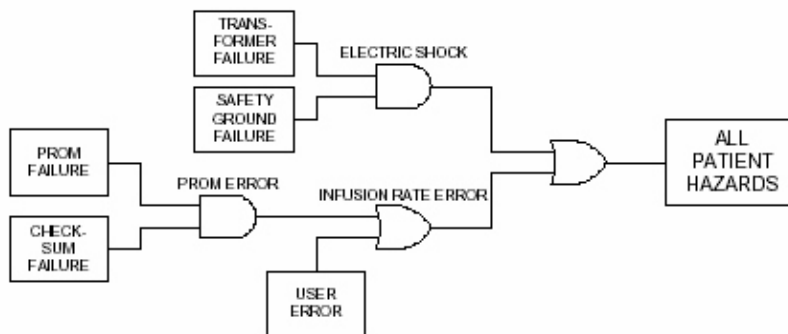
Figure 7. Possible AECL hardware Fault tree after hazard analyses in 1983 [2]

AECL had relied on their software that is why they excluded it from the FTA. AECL engineers had never thought that software could take any place in accidents. This overconfidence showed after the first accidents that were never diligently investigated. After the second accident AECL seem not to be sure about the real reason of the accident, but could only speculate. The hardware microswitch failure seems to be unlikely the reason for the accidents to happen.
